Structural Evaluation of SCDOT Prestressed Channel Bridges

**STRUCTURAL EVALUATION OF SCDOT
PRESTRESSED CHANNEL BRIDGES**

A Thesis
Presented to
the Graduate School of
Clemson University

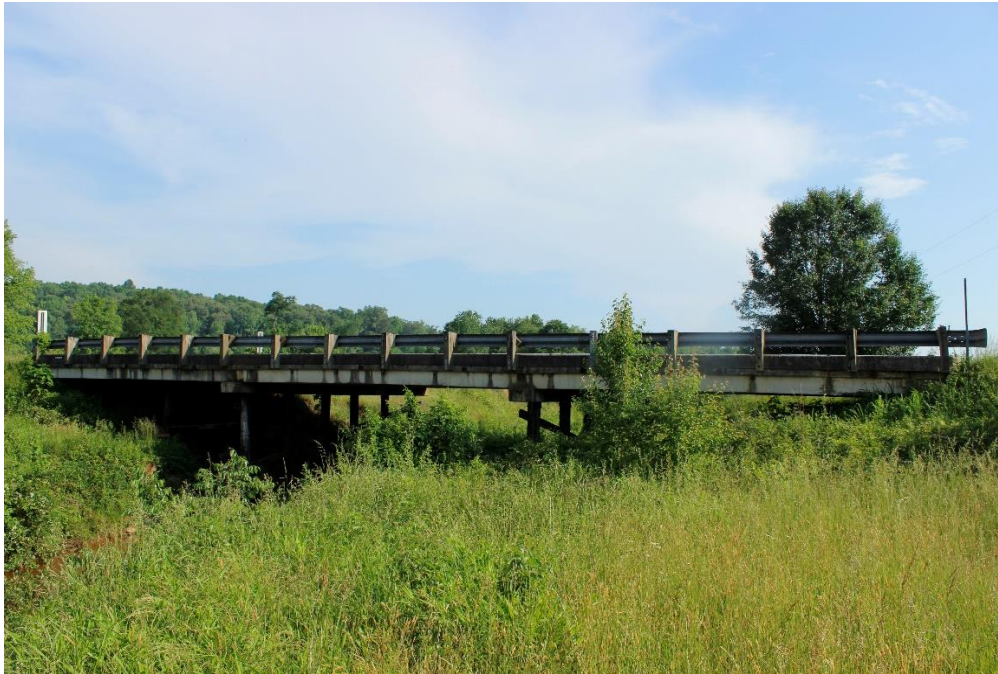
The Five Forks Bridge over Eighteenmile Creek in Liberty, SC is an example of this prestressed channel design and is the focus of this research. Figure 1-3 shows a view of the bridge from the north. The three simply supported spans can be seen as well as the substructure beneath.

Figure 1-3: Five Forks Bridge

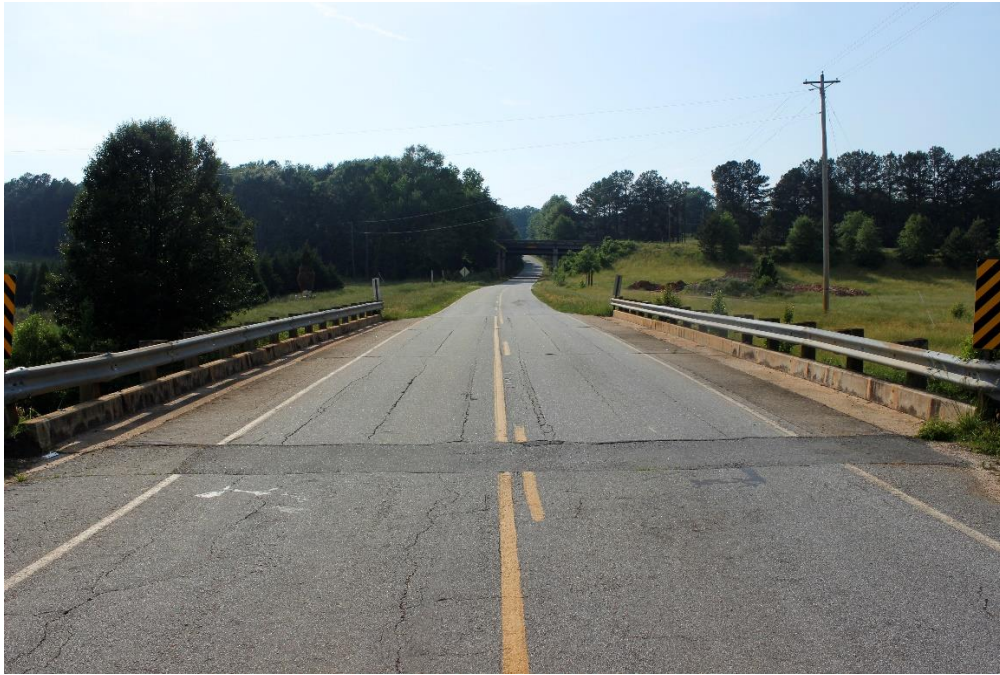
Figure 1-4 is a westward view of the two traffic lanes and the road surface of the bridge. All three spans are visible and cracks can be seen in the wearing surface at each longitudinal girder-to-girder joint. The approach on the eastern span can be seen in Figure 1-4. There is a slight bump in the approach that bounces vehicles as they drive across the bridge.

Figure 1-4: Traffic Lanes

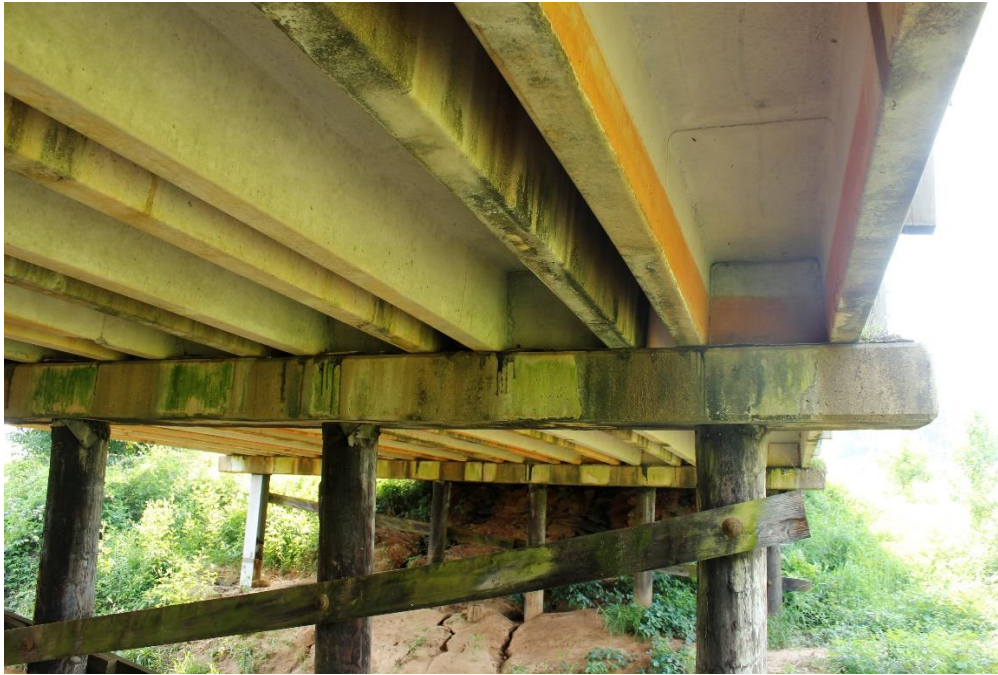
Figure 1-5: Bottom of Superstructure and Substructure

The bottom of the bridge superstructure and the substructure are shown in Figure 1-5. This offers a plain view of the girder geometry; the channel flange and both webs can be seen. The substructure beneath consists of timber piles supporting a concrete bent cap.

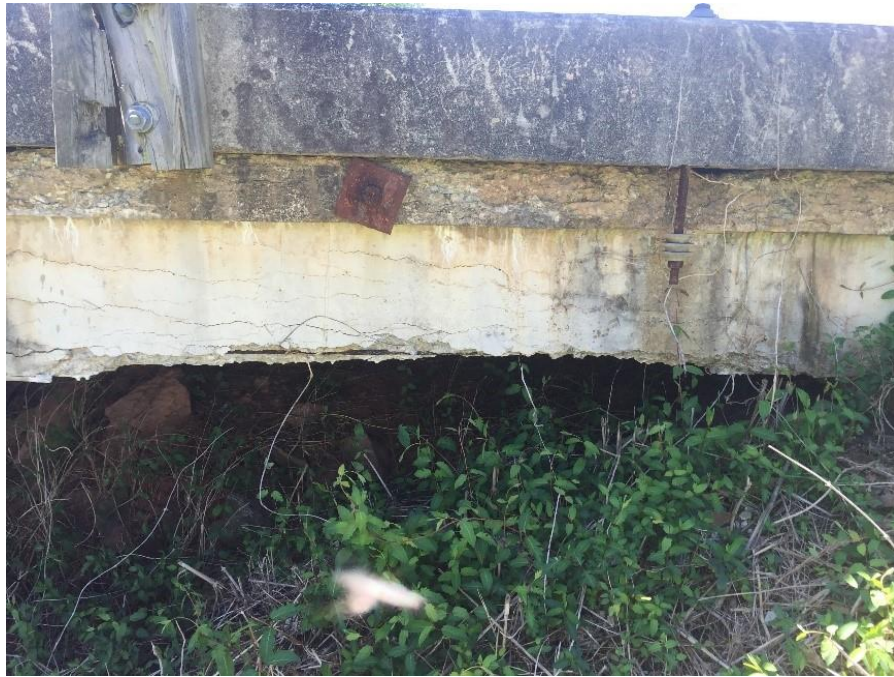
The purpose of this project is twofold: 1) to evaluate the condition of and develop a posting recommendation for the Five Forks Bridge and 2) to use the Five Forks Bridge as a basis for creating a system for SCDOT to assess the health of the other bridges in the state that use the same superstructure. The Five Forks Bridge is a three span, simply supported bridge where the West span has a damaged exterior girder and the East and Middle spans have all visually-determined healthy girders. The damage to the girder is shown in Figure 1-8. The bottom of one of the flanges has concrete that has spalled off resulting in some prestressing strands being exposed and partially corroded.

Figure 1-8: Exterior Girder Damage

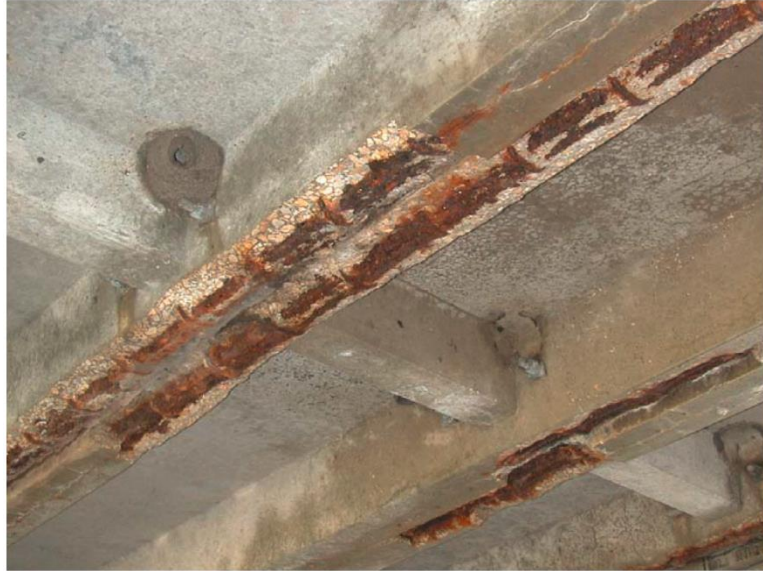
Almost all of the states with these channel bridges reported damage similar to what is found in the Five Forks Bridge. This damage includes concrete that has spalled

off the flanges and corrosion present on the flexural reinforcement. Figure 2-4 below shows a common example of this type of damage.

Figure 2-4: Example of Corrosion and Spalling (Klaiber, et al 2001)

The chemical reaction that forms rust causes the reinforcing bars to expand and crack the surrounding concrete. Cracked concrete can speed up the corrosion process

until concrete spalls at the flanges. Corroded reinforcing bars have a decreased cross-sectional area and a weaker bond with the surrounding concrete than reinforcing bars that aren't corroded. This corrosion results in a decreased flexural strength (Durham 2003). Conclusions from an Iowa State study identified this widespread and identical damage in concrete channel bridges as a national issue that needs addressing (Klaiber, et al 2001).

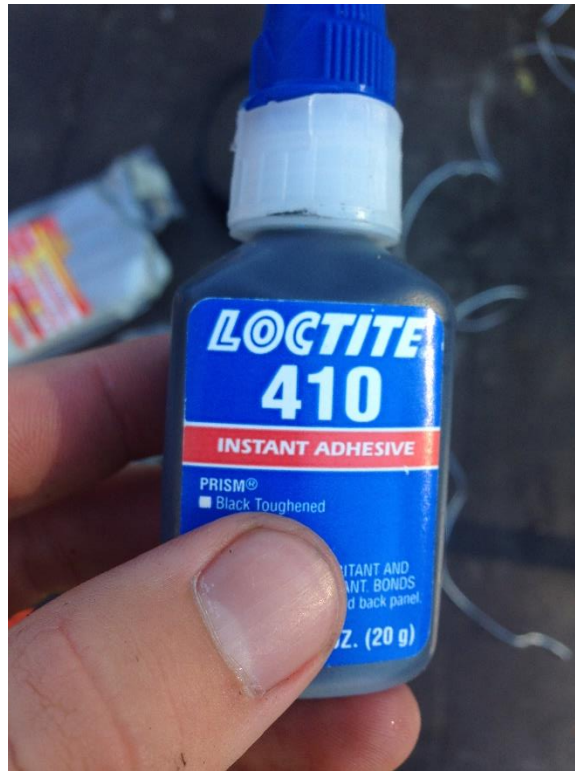
Figure 3-4: Loctite Adhesive

The process of attaching the strain transducers to the concrete surface of the girders was a simple task. BDI provides a set of small metal tabs with each transducer which act as feet to secure the transducers. The nuts seen on each end of the transducers in Figure 3-3 attach these tabs to the transducer. A two-part epoxy was used to glue these feet onto the girders. Figures 3-4 and 3-5 below show the adhesive and accelerant that make up this epoxy.

To ensure a good connection, the surface of the girder was prepared by smoothing any noticeable roughness. The future location of the transducer was coated in a thin layer of adhesive and then sprayed with accelerant. The feet of the transducer were also coated in adhesive and then sprayed with accelerant. The epoxied feet were pressed against the epoxied surface for a few seconds until a secure bond was formed. These strain transducers were attached the night before the test so the intelligiducers used to connect them to the channels were wrapped in plastic bags and duct taped closed so no moisture could affect them. These cables were held up with cable ties attached to the underside of the girders.

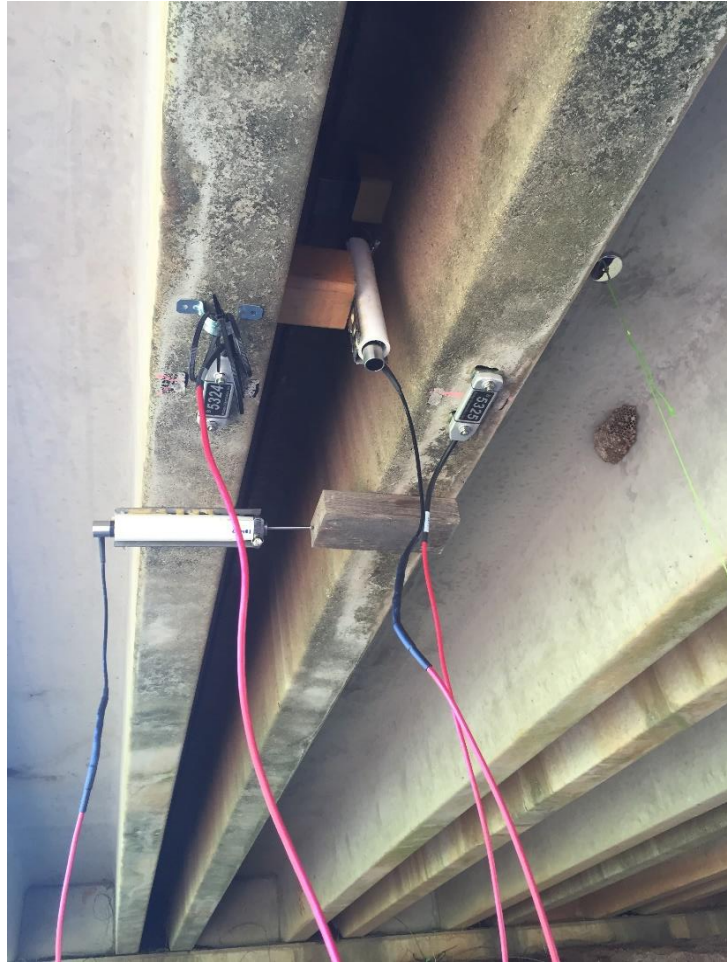
Figure 3-9: Horizontal and Vertical LVDT Setup

Figure 3-9 shows how this setup was implemented at the Five Forks Bridge. A horizontal and vertical LVDT can be seen spanning the distance between the two girders. A strain transducer at the bottom of each girder stem can also be seen.

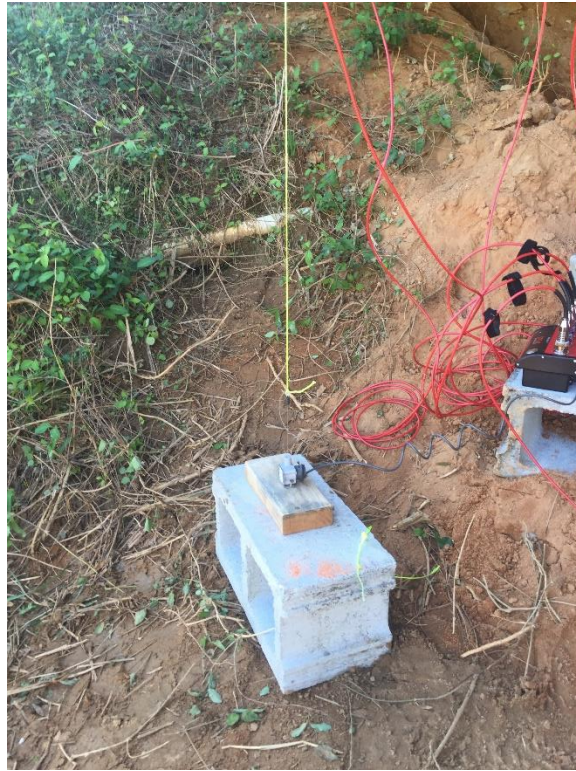
Figure 3-10: String Pot Anchor

The string pots used the ground beneath the bridge as the reference for the absolute deflection. The string pot's exterior consisted of a metal bracket that was attached to a piece of wood. This wood was glued to a concrete block with the same two part epoxy used to attach the instruments to the girders. This concrete block served as an anchor that kept the string pot casing locked in one location while the string itself could move with the bridge. The string could not reach from the ground to the bridge so extension wire was used to bridge the distance. The extension wire was connected to a metal hook glued to the bottom of the girder web at mid-span. The string was pulled out about halfway of its total stroke before being tautly tied to the wire. It was checked that no slack was in the wire or string. The string was pulled out so it could register positive and negative vertical deflection of the girders. Figures 3-10 and 3-11 show the entire setup of the string pots.

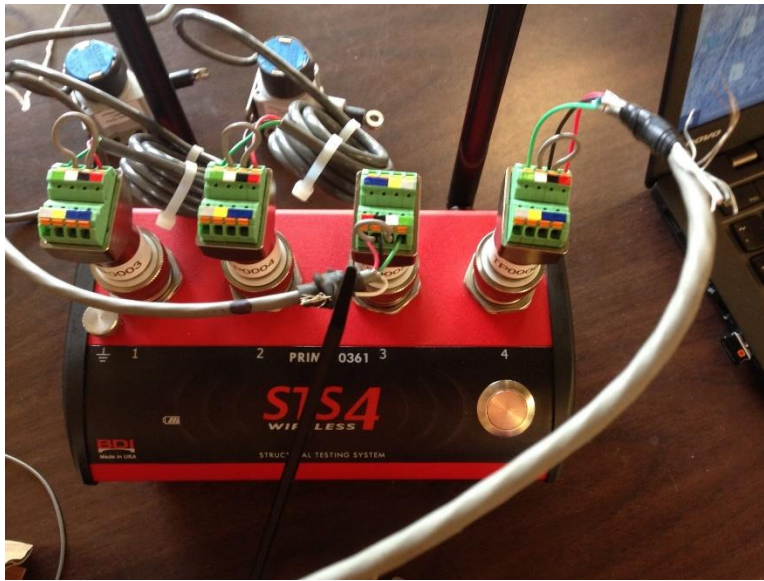
Figure 3-12: STS4-4 Receiver with Wired String Pots

A BDI data acquisition system was used to collect and record the data from the field test. STS4-4 nodes are 4-channel data acquisition devices that were connected directly to all instruments. The strain transducers and LVDTs from BDI connected to the nodes through an intelliducer provided by BDI, however, the string pots were connected manually. Figure 3-12 shows a STS4-4 receiver with manually wired string pots.

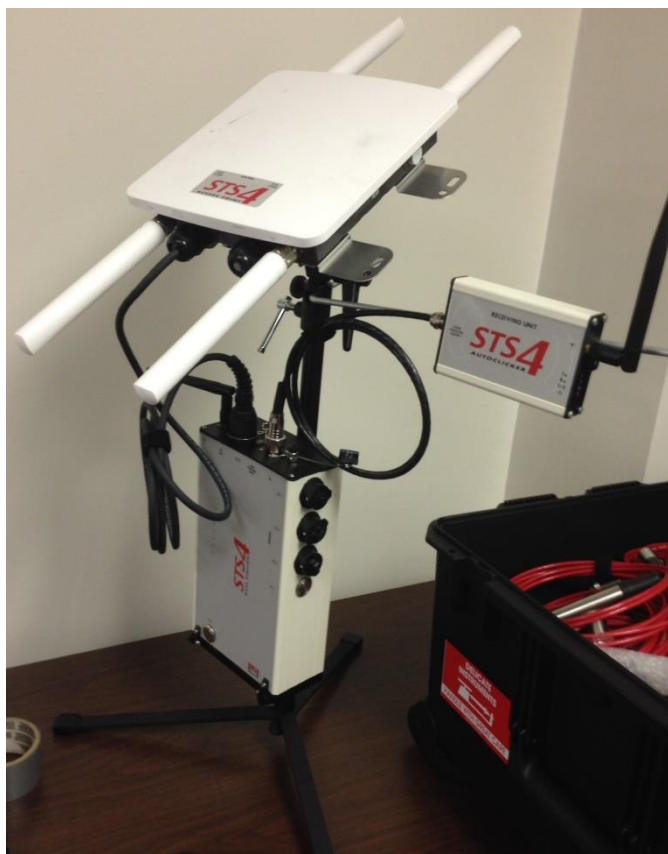
Figure 3-13: STS4 Base Station

Each of the six receivers was placed on top of a cement block directly beneath the four instruments it was attached to. The concrete block was used to keep dirt off of the receiver. These receivers were wirelessly connected to the central base station. The STS4 Base Station created a wireless signal that was used to collect the data from all of the STS4 receivers. Figure 3-13 shows the STS4 Base Station. This wireless connection also connected the base station to the laptop that ran the STS-Live software. The STS-Live application allowed the bridge response to be viewed in real time to ensure all data was usable. Figure 3-14 below shows a schematic of the data acquisition setup and how everything was connected.

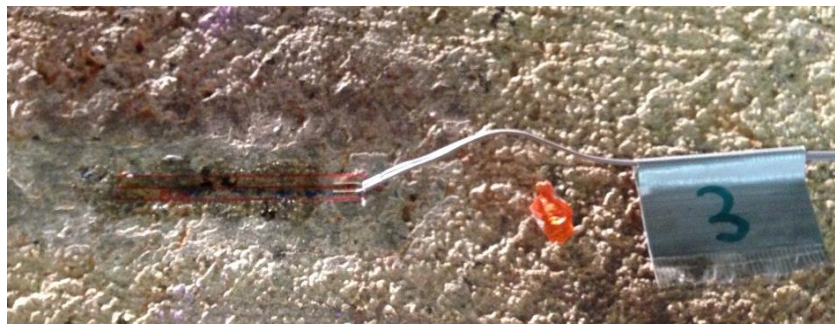
The strain gages used were made by the Tokyo Sokki Kenkyujo Co. These were 60 mm (2.36 in.) long polyester strain gages designed for concrete use. The strain gages did not need to be calibrated, but the strain recorded was compared to the strain recorded by the BDI strain transducers used in the nondestructive test of the Five Forks Bridge. A BDI transducer was placed beside a strain gage and the strains were compared. It was found that the strain transducers and gages recorded very similar values. Strain gages were attached to the top of the channel at mid-span with a Cyanoacrylate-based adhesive. Of these three strain gages, one was placed over top of each stem and one placed in the middle between the stems. Two strain gages were placed on the bottom of each stem at mid-span; these gages were centered on the stems. Figure 4-4 shows the gages attached to the channel.

Figure 4-4: Attached Strain Gages

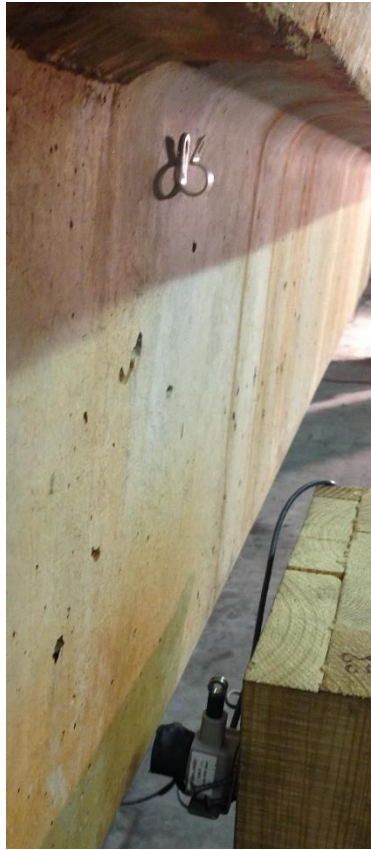
Figure 4-5: String Pots on Channel

Four of the same Celesco SM-25 string pots used for the nondestructive test of the Five Forks Bridge were used for the laboratory test. The accuracy of these string pots is 0.0625 in. The string pots were calibrated using a dial gage stand. The string pots were pulled to a known deflection. The deflection and corresponding resistance were plotted

for multiple distances. A linear equation was fit to the plot, this equation was used to convert the recorded resistances to distances. A separate equation was used for each of the four string pots. Deflection at mid-span was of interest so two string pots were attached to each web of the channel at mid-span. The string pot strings were attached to plastic hooks glued to the side of the channel at the neutral axis. To attach the string pots stiff wire was wrapped around the hooks and looped through the string pot ends. Concrete blocks were used as anchors for the casings of the string pots. Figure 4-5 shows a string pot attached to the channel. The other two string pots were attached 12 in. from the ends of the beam to measure the deflection near the supports. These string pots were attached to hooks glued to the side of the channel at the neutral axis. Some pieces of cross-laminated timber were used to anchor the casings of the string pots.

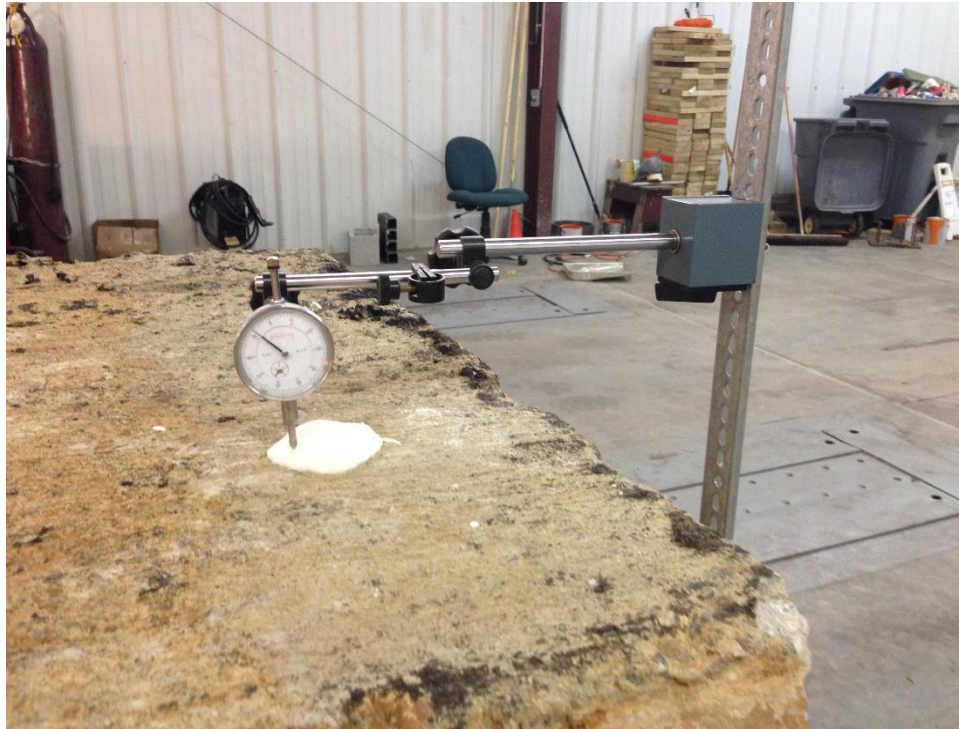
Figure 4-6: Dial Gage at Bearing of Channel

A dial gage from Mitutoya with an accuracy of 0.0001 in. was used at the end of the channel to record compression of the bearing pads. This overall channel settlement was subtracted from the deflection that the string pots recorded at mid-span to ensure more accurate recordings. Figure 4-6 shows the dial gage at the bearing of the channel.

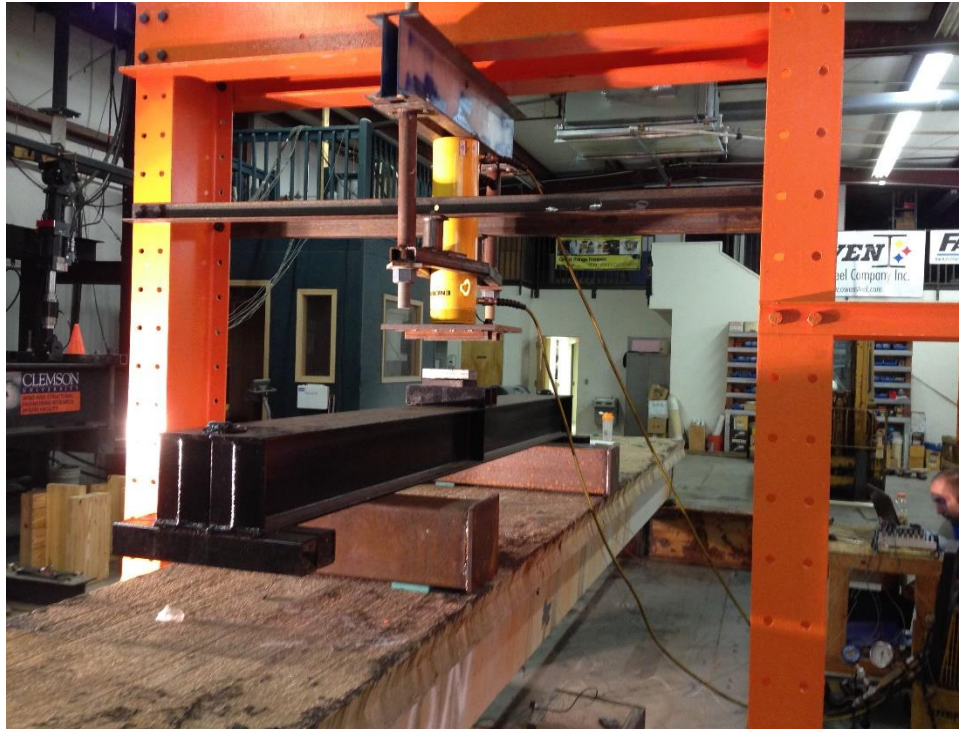
Figure 4-9: Channel Setup

The setup consisted of a reaction frame, hydraulic actuator, and a spreader beam to distribute the load. The actuator and jack hung from the cross head of the reaction frame. The pressure was applied to the center of a spreader beam consisting of two W8x18 beams welded together. The spreader was centered on the channel transversely and longitudinally. It was supported by two transverse tubes (HSS 8x8x $\frac{3}{16}$ in.). The tubes were centered transversely but offset 3 ft. on each side of the channel center line. The tubes were 6ft. apart and created a constant moment region at the middle 6 ft. of the channel. The tubes rested on 1 in. thick bearing pads located directly above the channel stems. The channel was supported by custom-made W-shaped members 18 in. deep and with flange widths of 8.66 in. These custom beams were bolted to the reaction floor. The custom beams were located 14'-6" from the center of the frame creating a total span length of 29'-0" between the custom abutments. Between the channel and abutment were 1 in. thick bearing pads and rollers that allowed lateral movement of the channel. Figure 4-9 shows the loading setup.

The channel was loaded in a four-point bending arrangement that can be seen in Figures 4-7, 4-8, and 4-9. Figures 4-7 and 4-8 show the elevation and plan views of the load test setup. Figure 4-9 is a picture taken before the test.

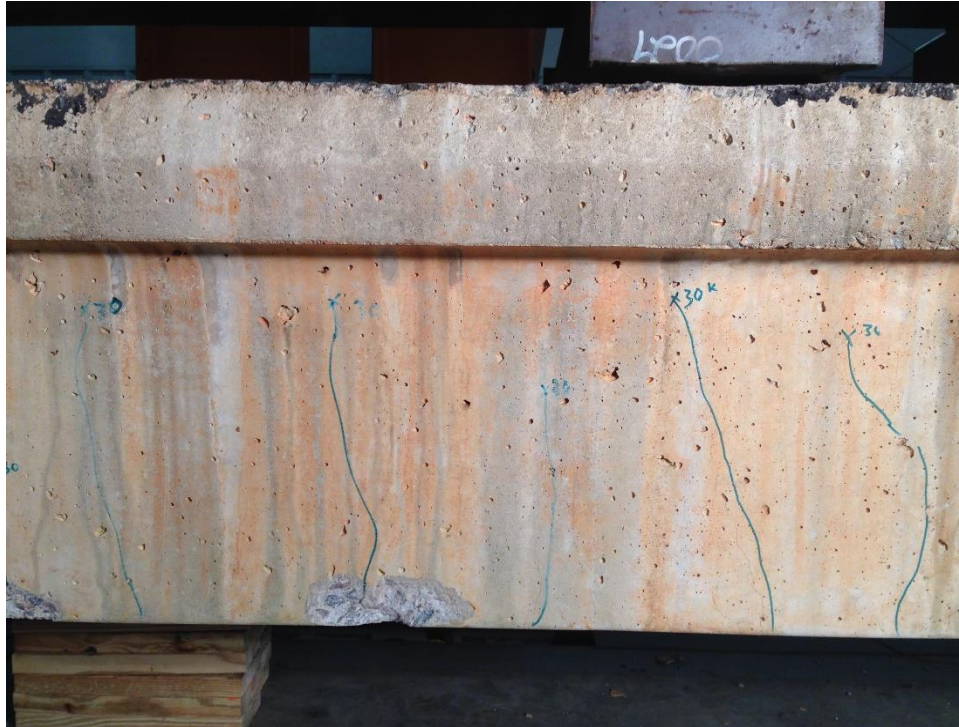
the expected failure load. The crack pattern on one side of the web at a load of 40 kips can be seen in Figure 4-10. The beam was loaded until failure.

Figure 4-10: Crack Pattern at 40 kips

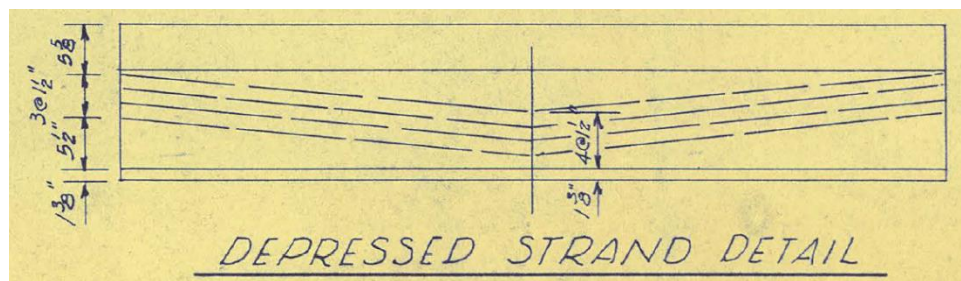
Figure 5-3: Design 1 Strand Profile

There are multiple differences between the two designs. The strand layout is different in each plan; Design 1 has 5 strands arrayed in a single column in each channel stem while Design 2 has 2 columns of 6 strands in each stem. The spacing of the strands and the center of gravity of the strands relative to the channel's neutral axis are different in each design. The strand eccentricity along the length of the span can be seen for Design 1 and Design 1 in Figures 5-3 and 5-4.

The strand material properties are different in each design as well. Design 1 contains 3/8 in. strands with a nominal capacity of 250 ksi. Design 2 contains 7/16 in. strands with a nominal capacity of 270 ksi. Due to these differences the flexural capacities of each design are significantly different.

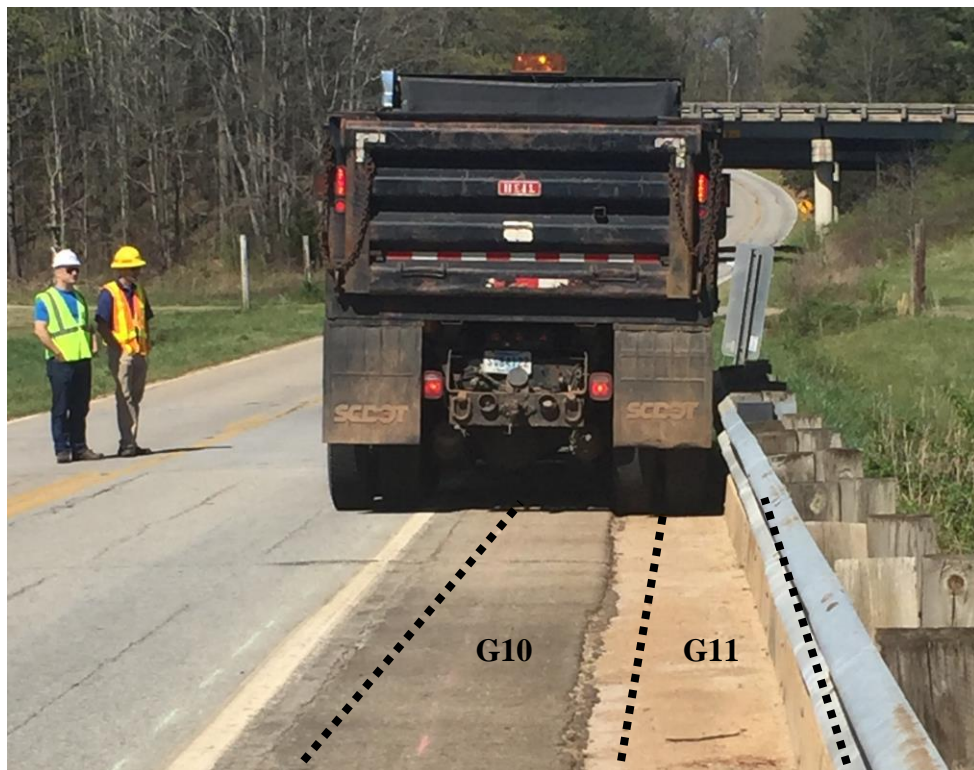
Although the data in Figure 5-10 does not exhibit a strong linear relationship for girder 11D it appears to be a function of the location of loading and not because the girder is nearing its capacity. If the girder was nearing its capacity then it would be expected that the strain for the heaviest truck would be much larger than the strain for the half-full truck, this is not the case though. The exterior girder is also difficult to load due to the bridge geometry and the presence of the barrier rail. Figure 5-11 shows the truck location necessary to load the exterior girders. Due to the difficulty in loading and the magnitude of the strain under the exterior loading, the damage in the west span is not a concern. Under normal traffic circumstances the damaged girder in the west span would not see a significant amount of load. Girders 10 and 11 are outlined in Figure 5-11 below and called out as “G10” and “G11” respectively.

Figure 5-11: Loading the Exterior Girder

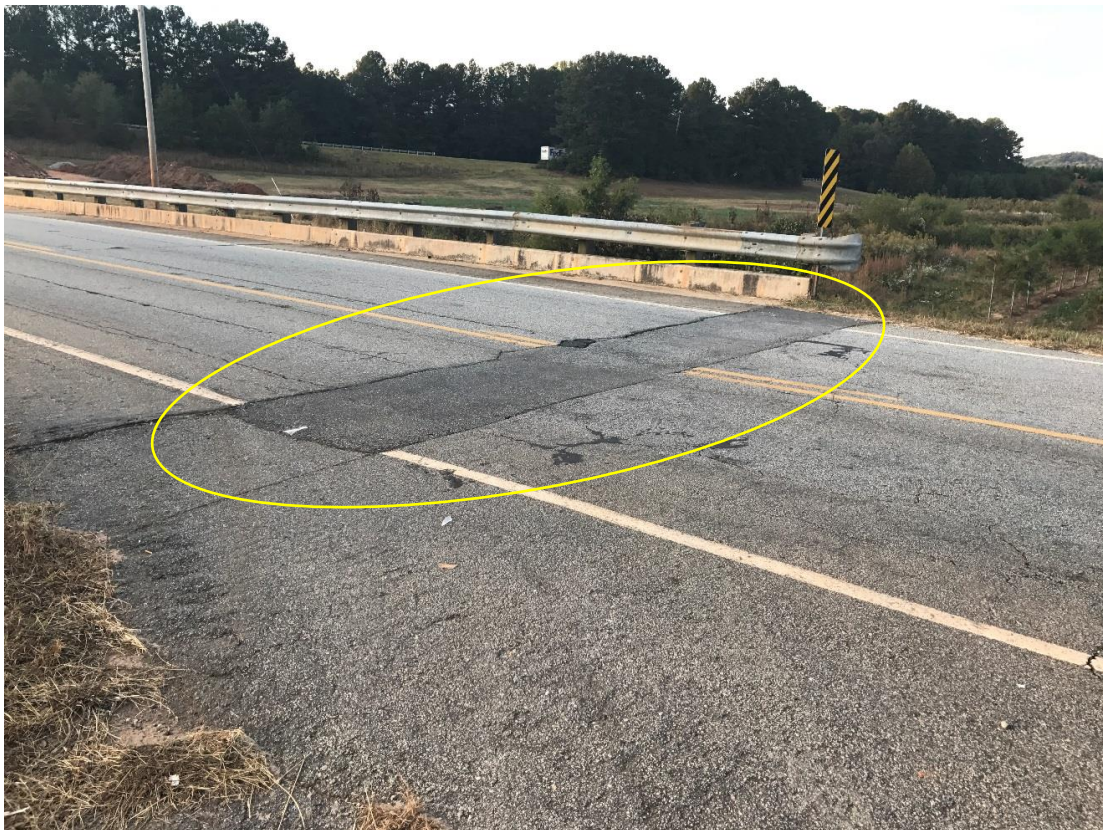
Section 2.2 mentioned multiple factors that affects IM such as bridge frequency, span length, truck weight, truck suspension, approach quality, and roadway roughness. All of these variables can't be quantified for the Five Forks Bridge and the dump trucks used in the scope of this project. A similar result occurred in a test conducted by Structural Testing Incorporated where a negative dynamic load effect was attributed to the combination of a short span and the contours of the approach (STI 1998). A picture of the approach for the Five Forks Bridge can be seen below in Figure 5-22.

Figure 5-22: Five Forks Bridge Approach

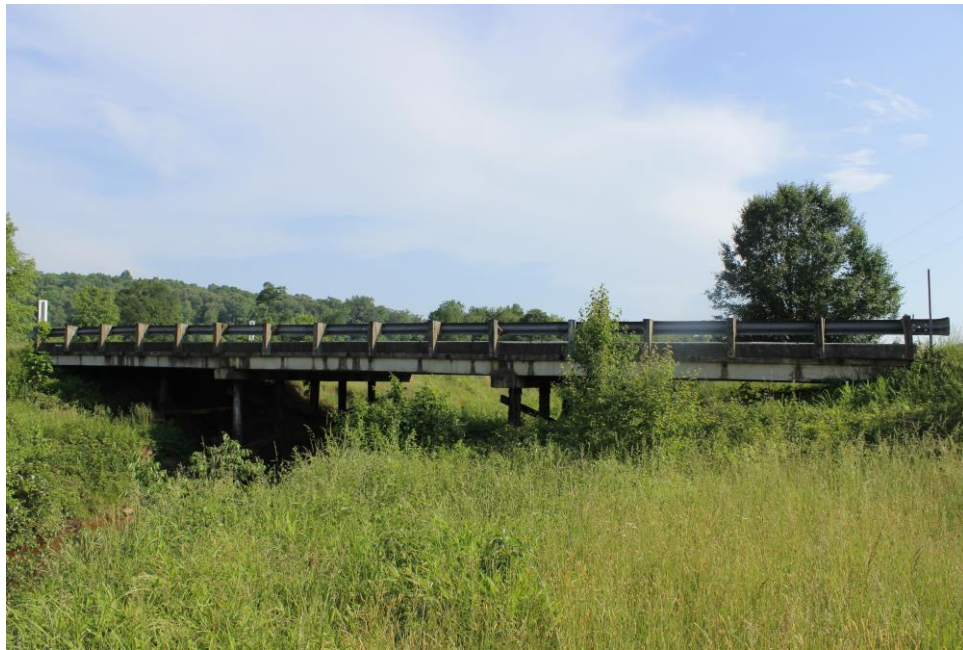
The Five Forks Bridge in Liberty, SC (Figure 7-1) is one of approximately 450 prestressed concrete channel bridges in the SCDOT inventory. Many of these channel bridges, such as the Five Forks Bridge, have unknown structural properties and flexural capacity. The Five Forks Bridge is a prestressed concrete channel bridge consisting of 33 girders that form three simple spans each 30 ft. in length.

Figure 7-1: Profile of Five Forks Bridge

The Five Forks Bridge in Liberty, SC (Figure 7-1) is one of approximately 450 prestressed concrete channel bridges that the SCDOT oversees. Some of these channel bridges, such as the Five Forks Bridge, have unknown structural properties and flexural capacity. The Five Forks Bridge is a prestressed concrete channel bridge consisting of 33 girders that form three simple spans each 30 ft. in length. There are no formal design calculations available for some of these bridges and there are multiple prestressed strand designs that may describe the physical properties of each bridge.
